BUILDING FOR ENERGY EFFICIENCY

Thermal imaging of post frame and other construction methods

This article is based upon a May 2010 report prepared for the National Frame Building Association by Double G Consulting (the complete report may be found at nfba.org/technicalarticles). The purpose of this study was to illustrate points of heat transfer in different building types using thermographic images. Builders and design professionals familiar with post-frame buildings know these buildings use fewer structural components to create an exceptionally economical, energy-efficient and environmentally friendly building because fewer structural members are needed, which creates wide spaces between posts with fewer breaks in insulation, and that wood has natural insulating properties compared to steel or masonry structural components. Post-frame construction is therefore believed to reduce some of the heat transfer observed in other construction methods because of wider insulation cavities and less thermal bridging. To illustrate these concepts, thermal images that provide visual examples of heat transfer were captured. The images highlight inefficiencies that may be caused by thermal brid

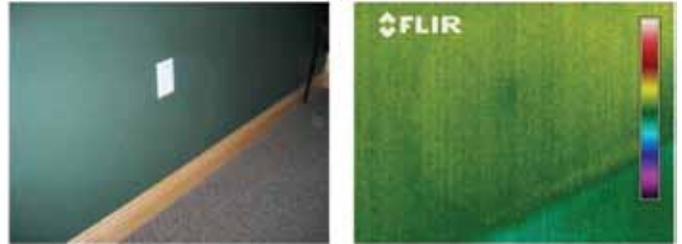
Figures 3, 4, and 5 are images taken inside the post-frame building. Figures 3 and 4 are typical exterior wall images. The temperature of the receptacle in **Figure 3** is very near that of the surrounding area, which indicates that the receptacle is not associated with a change in temperature due to air infiltration and/or a reduced thermal resistance. Similarly, the thermogram in **Figure 4** shows uniform temperatures along the wall surface.

Figure 3. Thermogram indicates no abnormal heat transfer at the receptacle.

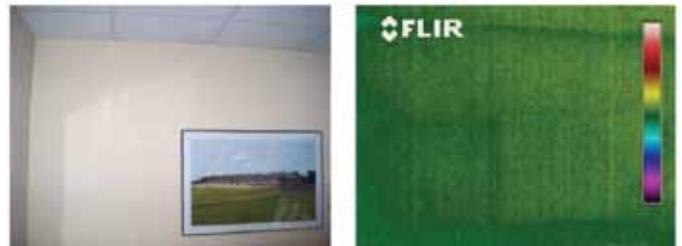
Figure 4. Typical exterior wall. Thermogram indicates no abnormal heat transfer.

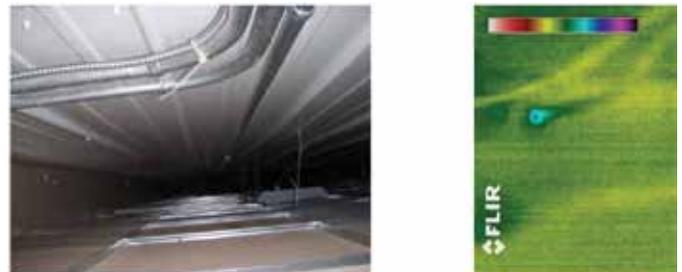
Figure 5 shows a region above the suspended ceiling. Although there are no signs of air infiltration or exfiltration at seams between corrugated steel panels, a spot on the electric conduit does register a colder temperature than the surroundings. Thermal bridging may be caused by a steel electrical box, bracket or screw.

Figure 5. Cavity above suspended ceiling. Although no signs of air infiltration or exfiltration at panel seams appear, a spot on the electric conduit does register a colder temperature than that of the surroundings.

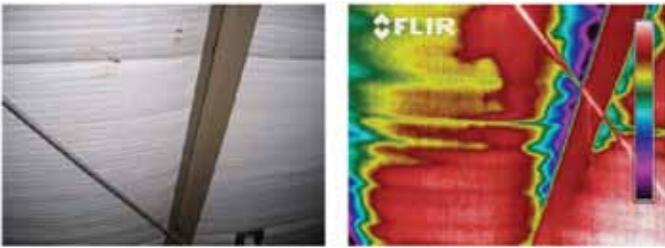
As shown in **Figures 7–10**, significant variations in thermal envelope heat transfer likely due to heat transfer were observed in this building, particularly at eave struts, roof purlins and columns. These variations were due primarily to compression of the fiberglass insulation at these framing members. When viewing the thermograms in **Figures 7, 8 and 9**, note the varia-

Figure 7. Thermogram of a single roof purlin shows increasing drop in surface temperature as thickness of insulation decreases near purlin.

tion in the temperature across each steel framing member. Inside flanges have temperatures closer to the building's interior temperature, while the flanges in contact with the compressed insulation have measurably lower temperatures.

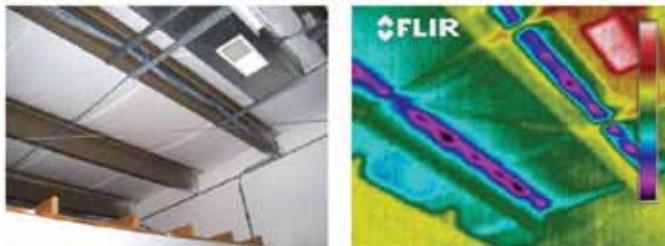
Figure 8. Thermogram shows similar temperature profiles for adjacent purlins.

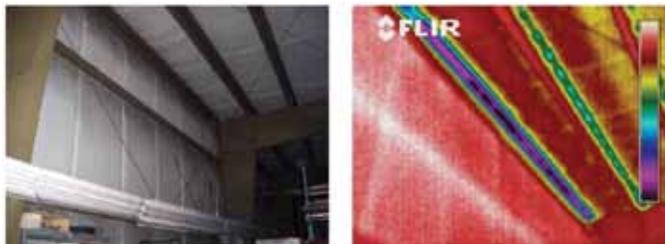
Figure 9. Image shows lowest temperatures occurring where insulation is compressed by eave strut. Exterior corners in all buildings are generally associated with greater heat loss per unit area.

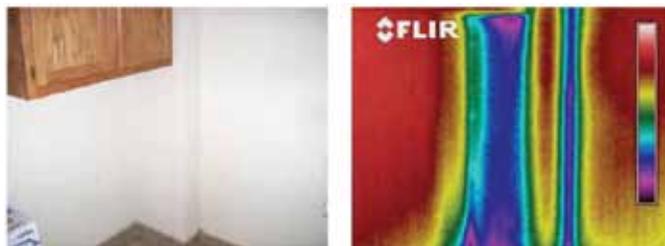
Figure 10. Covering around each steel column showed a similar temperature profile, a pattern indicating elevated heat transfer at column locations.

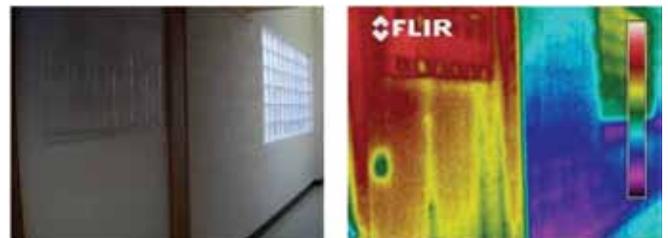
Figure 12. Images of the transition between the insulated and non-insulated concrete block walls in the masonry building.

The thermogram in **Figure 12** is as definitive as you will find in thermal imaging. In this case, it shows the difference a small amount of wall insulation can make, as well as elevated heat transfer near an uninsulated foundation. The thermogram in **Figure 12** also shows the interior surface of the glass block and mortar between the glass block to be at a higher temperature than the surrounding concrete block. This is most likely due to transmittance of solar radiation through the glass block.

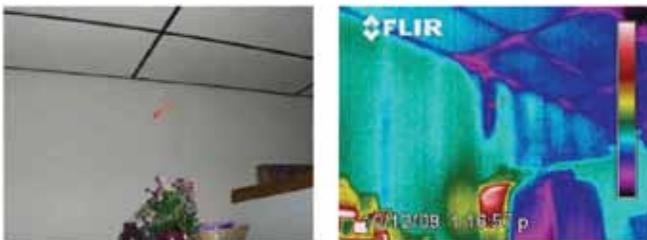
Figure 14. Air infiltration into a wall cavity during blower door testing

The wood stud-framed building was relatively leaky, with a measured infiltration of 10,300 cubic feet per minute at 50 pascals of differential pressure. Blower door testing revealed measurable air infiltration at bottom and top plates, as well as air exchange between wall cavities and the adjacent attic zone as a result of electrical and other penetrations through the framing (see **Figure 14**). These penetrations can be resolved with appropriate measures.

The most significant air leakage in the wood-stud building was at the ceiling, as evidenced by the lower temperatures around the suspended ceiling grid in **Figure 14**.

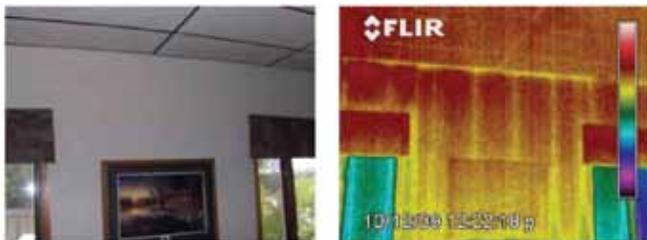
Figure 15. Thermogram shows lower surface temperatures in areas backed by wood studs.

As shown in **Figure 15**, the stud-wall building showed reduced thermal resistance at wall studs, indicated by the streaking color in the wall. Depending on the size of framing used for a wall (2x4, 2x6, etc.) and the spacing of the studs, the heat loss through framing can vary from 33 percent to 49 percent of the total (Seifert, n.d.).
