BUILDING FOR ENERGY EFFICIENCY

Thermal imaging of post frame and other construction methods

This article is based upon a May 2010 report prepared for the National Frame Building Association by Double G Consulting (the complete report may be found at nfba.org/technicalarticles). The purpose of this study was to illustrate points of heat transfer in different building types using thermographic images. Builders and design professionals familiar with post-frame buildings know these buildings use fewer structural components to create an exceptionally economical, energy-efficient and environmentally friendly building because fewer structural members are needed, which creates wide spaces between posts with fewer breaks in insulation, and that wood has natural insulating properties compared to steel or masonry structural components. Post-frame construction is therefore believed to reduce some of the heat transfer observed in other construction methods because of wider insulation cavities and less thermal bridging. To illustrate these concepts, thermal images that provide visual examples of heat transfer were captured. The images highlight inefficiencies that may be caused by thermal brid

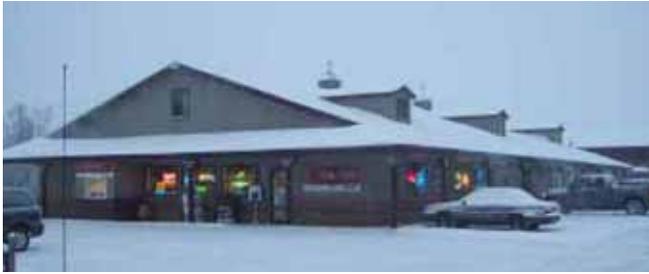
Figure 2. Post-frame building involved in thermal envelope study

envelope study is shown in **Figure 2**. This structure was a mixed-use facility (office and commercial retail) with R-19 fiberglass insulation in the walls, R-38 cellulose insulation in the ceiling, and R-8.1 polystyrene insulation encasing the perimeter of the foundation.

The post-frame building's blower door test measured 4,700 cubic feet per minute of leakage at 50 pascals of differential pressure. This infiltration appeared to occur at electrical and plumbing penetrations, a problem that can be investigated (and subsequently resolved) with minor measures taken prior to completion of construction. Differential surface temperatures may also indicate higher heat-transfer rates where insulation is interrupted by posts or laminated wood columns and at floor-to-wall junctures, or thermal bridging.

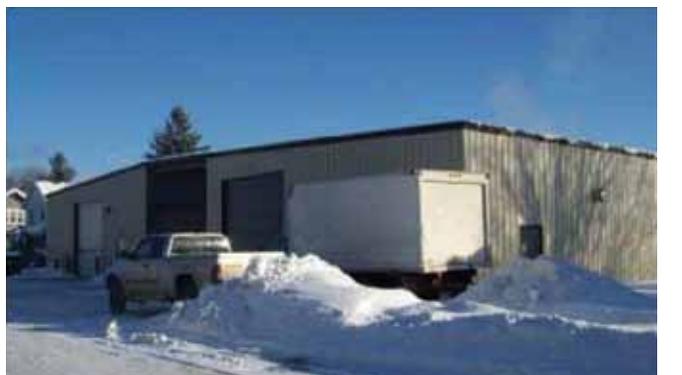
Figure 6. Rear view of low-rise steel-frame building involved in thermal envelope study

An image of the low-rise steel-frame building investigated as part of the NFBA thermal envelope study is shown in **Figure 6**. This facility housed a news publishing business and featured R-19 fiberglass insulation in the walls and R-19 fiberglass insulation in the ceiling. The perimeter of the foundation was not insulated. This was a massive building combined with major air leakage points; it was not possible to depressurize the building.

During the analysis of the steel-frame building, lower surface temperatures were located near base plates, indicating higher heat transfer due to the lack of foundation perimeter insulation

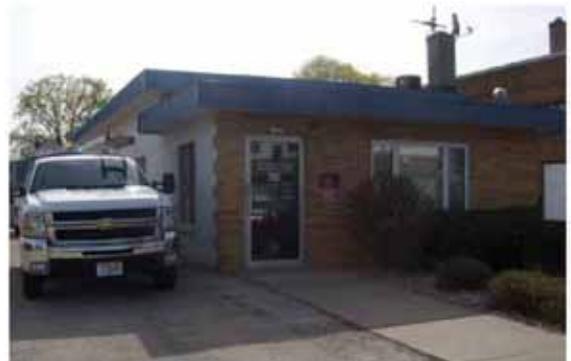
Figure 11. Masonry building involved in thermal envelope study

An image of the masonry building investigated as part of the NFBA thermal envelope study is shown in **Figure 11**. This structure was a utility facility. The front office portion featured concrete block furred out with 2x2 lumber and insulated with R-5.8 fiberglass batts. The rear portion of the structure was untreated concrete block ($R = \sim 1.0$). Ceilings were insulated with R-19 fiberglass batts. There was no foundation insulation.

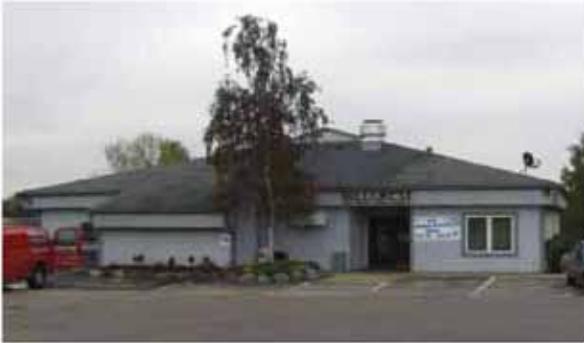
Figure 13. Wood stud-framed building involved in thermal envelope study.

An image of the wood stud-framed building investigated as part of the NFBA thermal envelope study is shown in **Figure 13**. This structure was a restaurant with 4,125 square feet of conditioned space and featured walls with R-11 fiberglass batt insulation and ceilings with R-38 cellulose insulation. The foundation perimeter was not insulated.

The wood stud-framed building was relatively leaky, with a measured infiltration of 10,300 cubic feet per minute at 50 pascals of differential pressure. Blower door testing revealed measurable air infiltration at bottom and top plates, as well as air exchange between wall cavities and the adjacent attic zone as a result of electrical and other penetrations through the framing (see **Figure 14**). These penetrations can be resolved with appropriate measures.
